Manhole Inspection Summary

Manhole # S35U__062MH

Insp Date: **2/14/08 10:24 AM**

Location Address: **1501 light st**

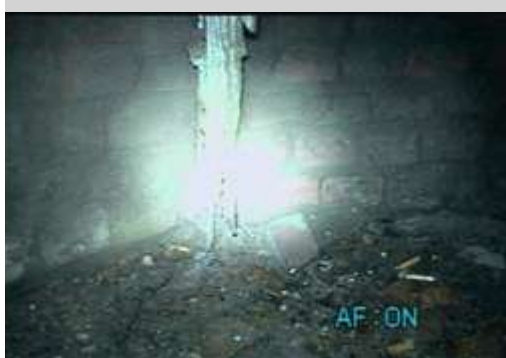
Miscellaneous

bench debris

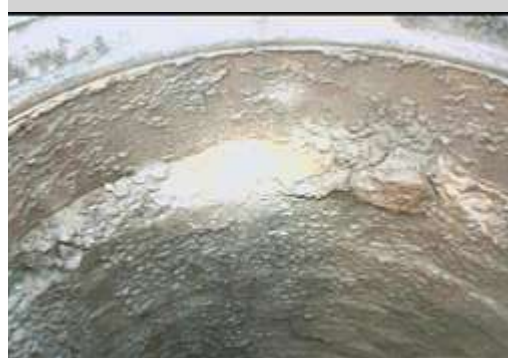
Defect 1

Condition: ☐ Sound ☐ Cracked ☒ **Leaks**

Condition: ☐ Sound ☐ Cracked ☐ Root Intrusion ☒ **Loose Brick** ☐ Deteriorated

Infiltration: ☐ None ☒ **Joint** ☐ Cracks ☐ Mortar ☐ Roots ☐ Wall

Frame Offset, Frame Leaks, corbel Loose Bricks, corbel Infiltration

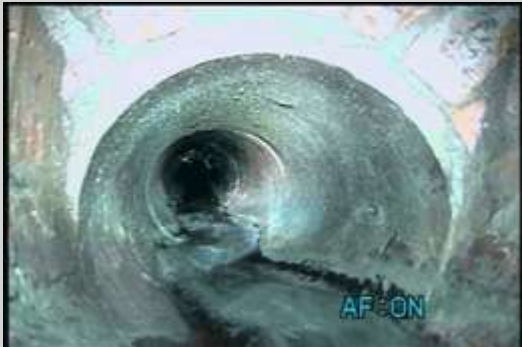
12 O'Clock Outflow

10 in. Circular Gravity Sewer
Pipe Out @ 12 O'Clock

Infiltration: **None** Pipe Seal Cond: **Unknown**

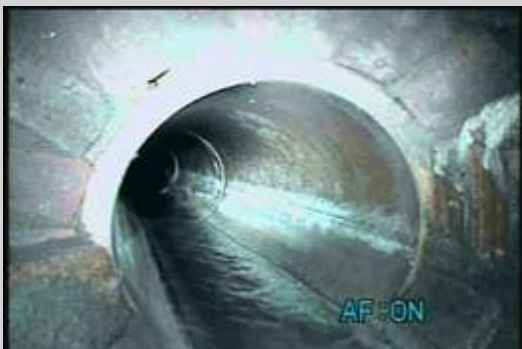
2 O'Clock Inflow

10 in. Circular Gravity Sewer
Pipe In @ 2 O'Clock

Infiltration: **None** Pipe Seal Cond: **Unknown**

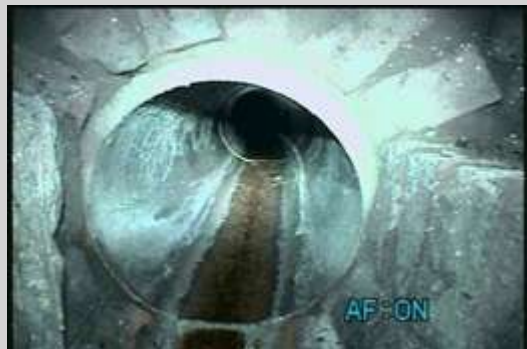
8 O'Clock Inflow

8 in. Circular Gravity Sewer
Pipe In @ 8 O'Clock

Infiltration: **None** Pipe Seal Cond: **Unknown**
